Doc. No:	EASY-ENTEC-D10.1
ISSUE:	1.1
<b>D</b> ATE:	
<b>Sheet:</b>	1 of 95
CLASSIFICATION:	Unclassified

Prepared by			
	Mattia Alladio,		
	Mattia Bussi,		
	Davide Marenchino,		
	Paolo Oberto,		
	Claudio Rinaudo		
	Verified by		
	Davide Marenchino,		
	Paolo Oberto		
	Approved by		
Marco Nisi			
Company			
ENTEC S.p.A.	recnologie per l'energia

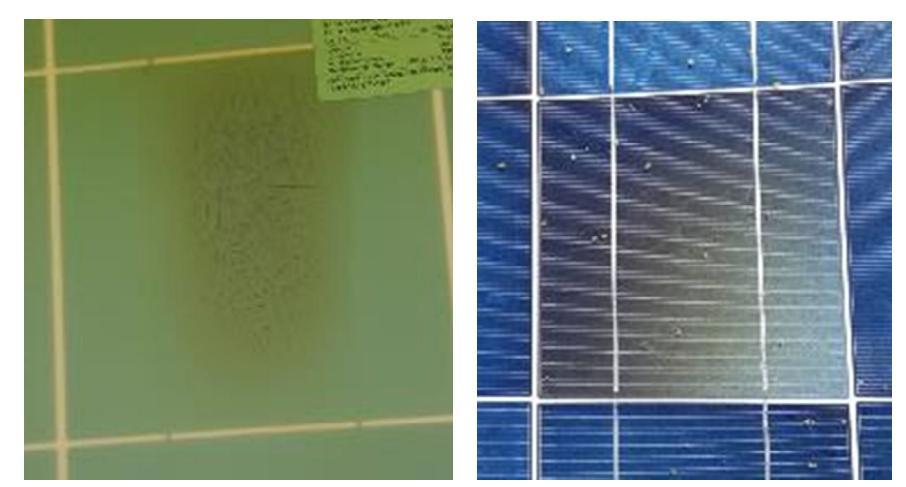
The most common fault detected on a PV module is the hot spot. It usually appears on modules in various ways, with different entities, related to the cell overheating. During IRSM, operator marks this type of anomaly through the evaluation of the cell temperature, compared to the rest of the module ( $\Delta t$ ). In extreme cases, it gets to have a  $\Delta t$  of 50 or 60°C where burning signs are visible in warm point. These anomalies are very dangerous for the PV plant safety and can induce fires.

Figure 3-23 Back-sheet with crack due to hot spot (left picture) - Hot spot cell with burned

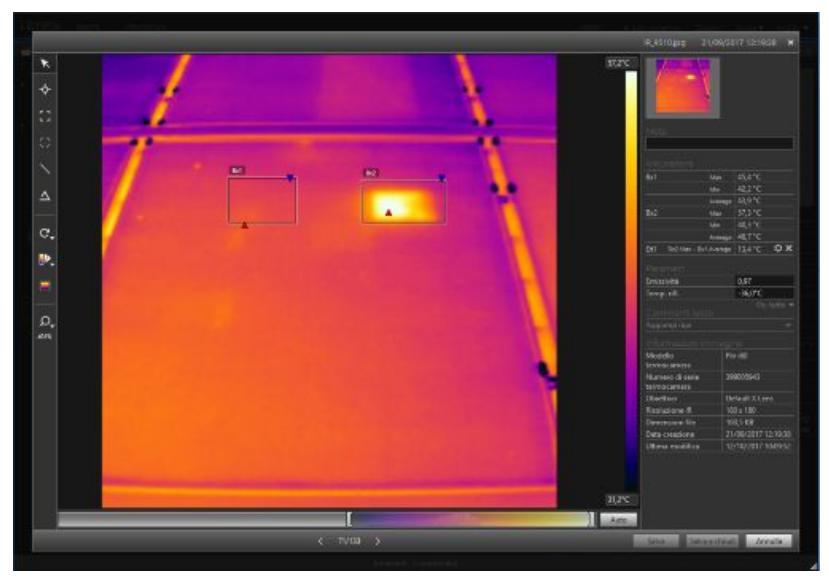
Figure 3-34- PVT1 - manual identification of "Hot spot"

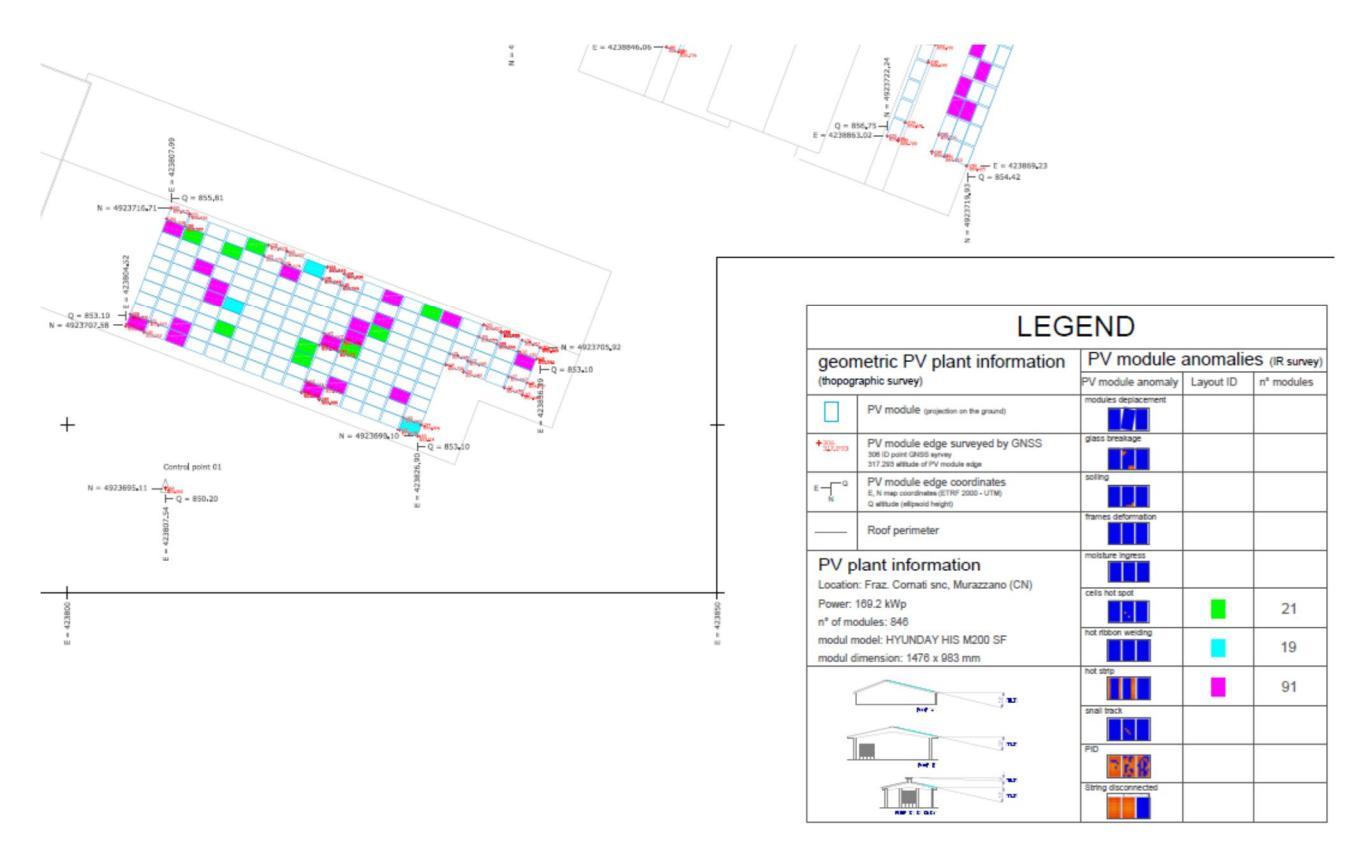
Figure 3-35 extract of PVT1 plant layout with anomalies indication

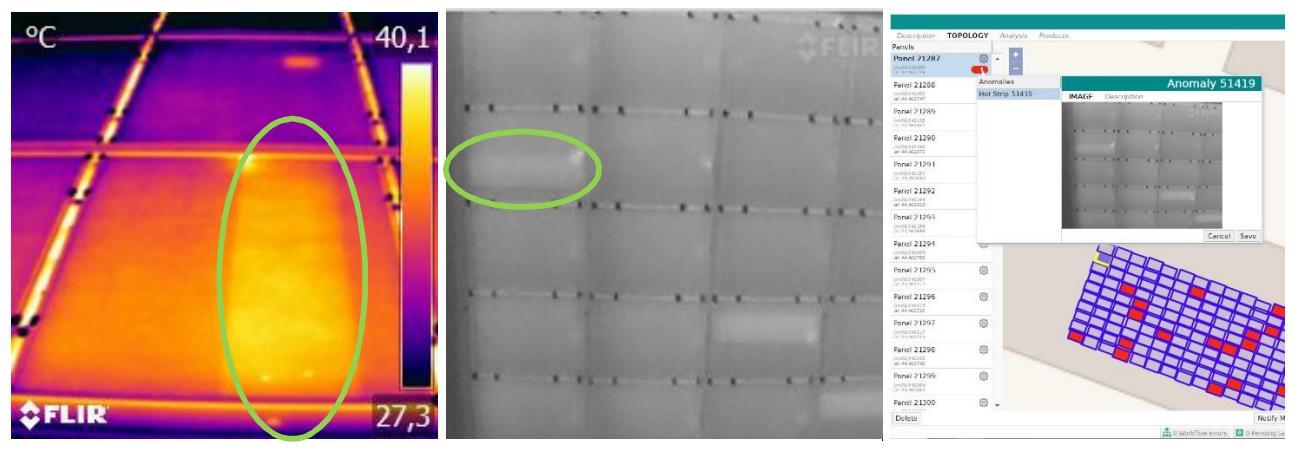
Figure 3-53 Right hot strip detection (IRSM, EPV-TO, EPV)

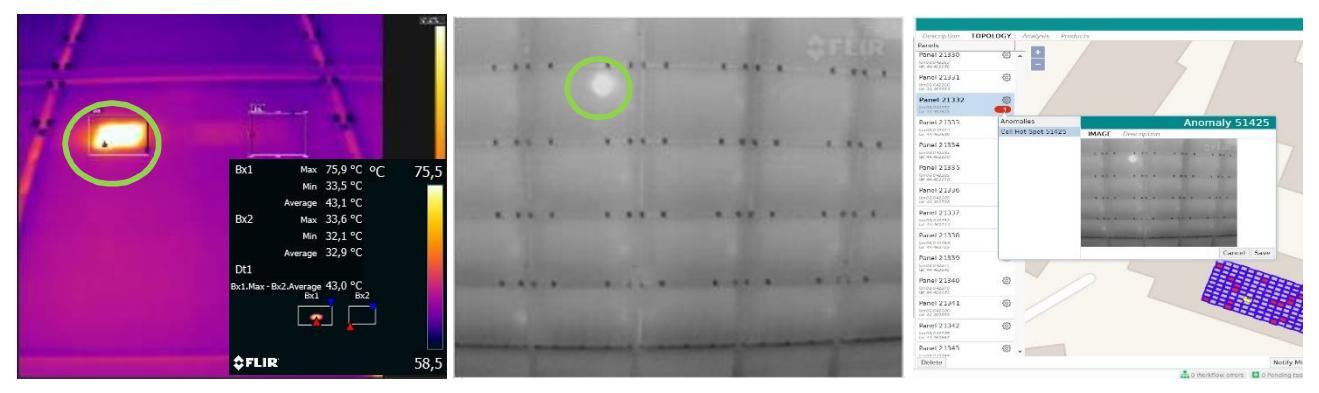
Figure 3-54 Right hot spot detection (IRSM, EPV-TO, EPV)

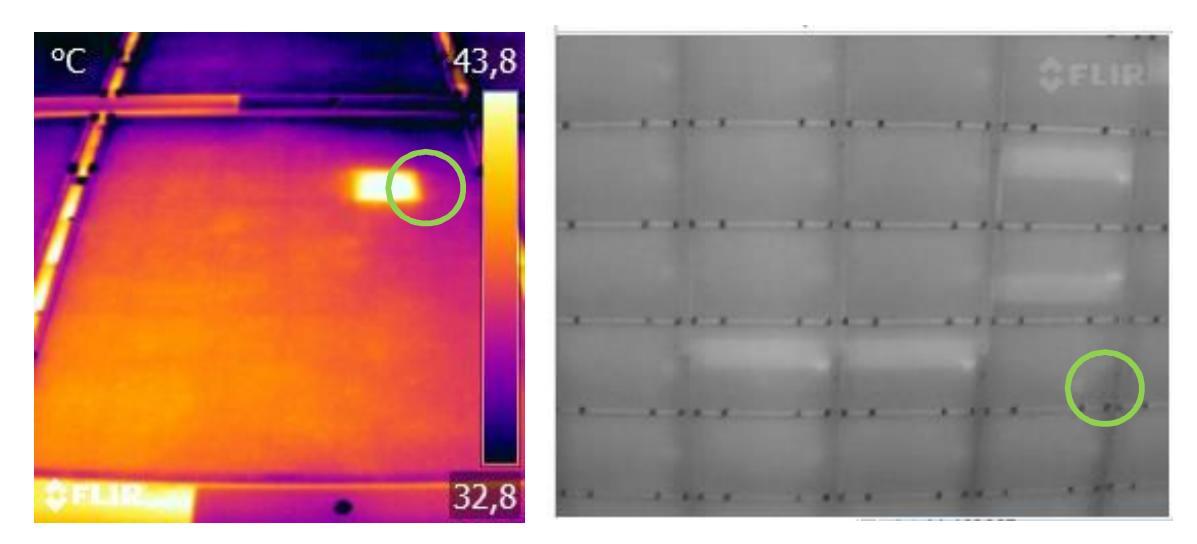
*Figure 3-55 Hot spot surveyed by IRSM and EPV-TO, but not identified by the automatic algorithm* No hot ribbon welds have been automatically detected. This problem is due to the poor information collected by

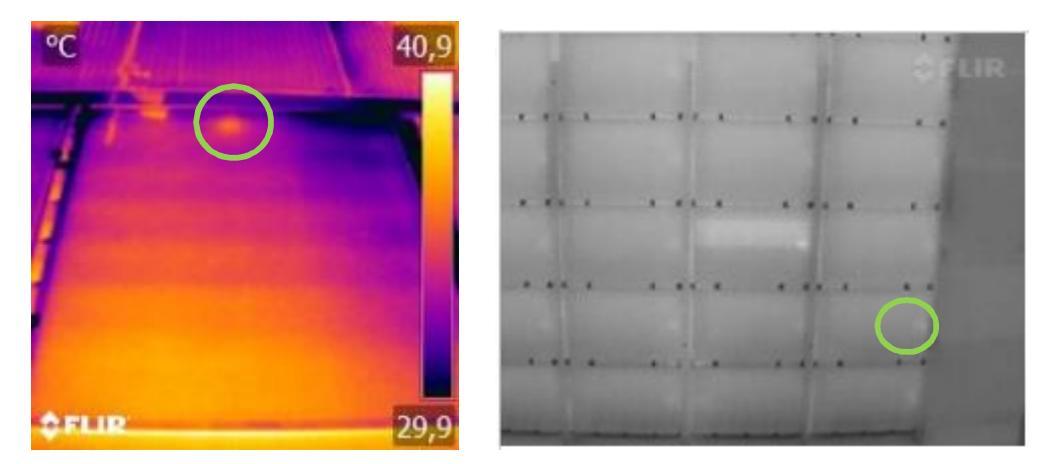
Figure 3-56 Hot ribbon welding surveyed by IRSM and EPV-TO, but not identified by the automatic

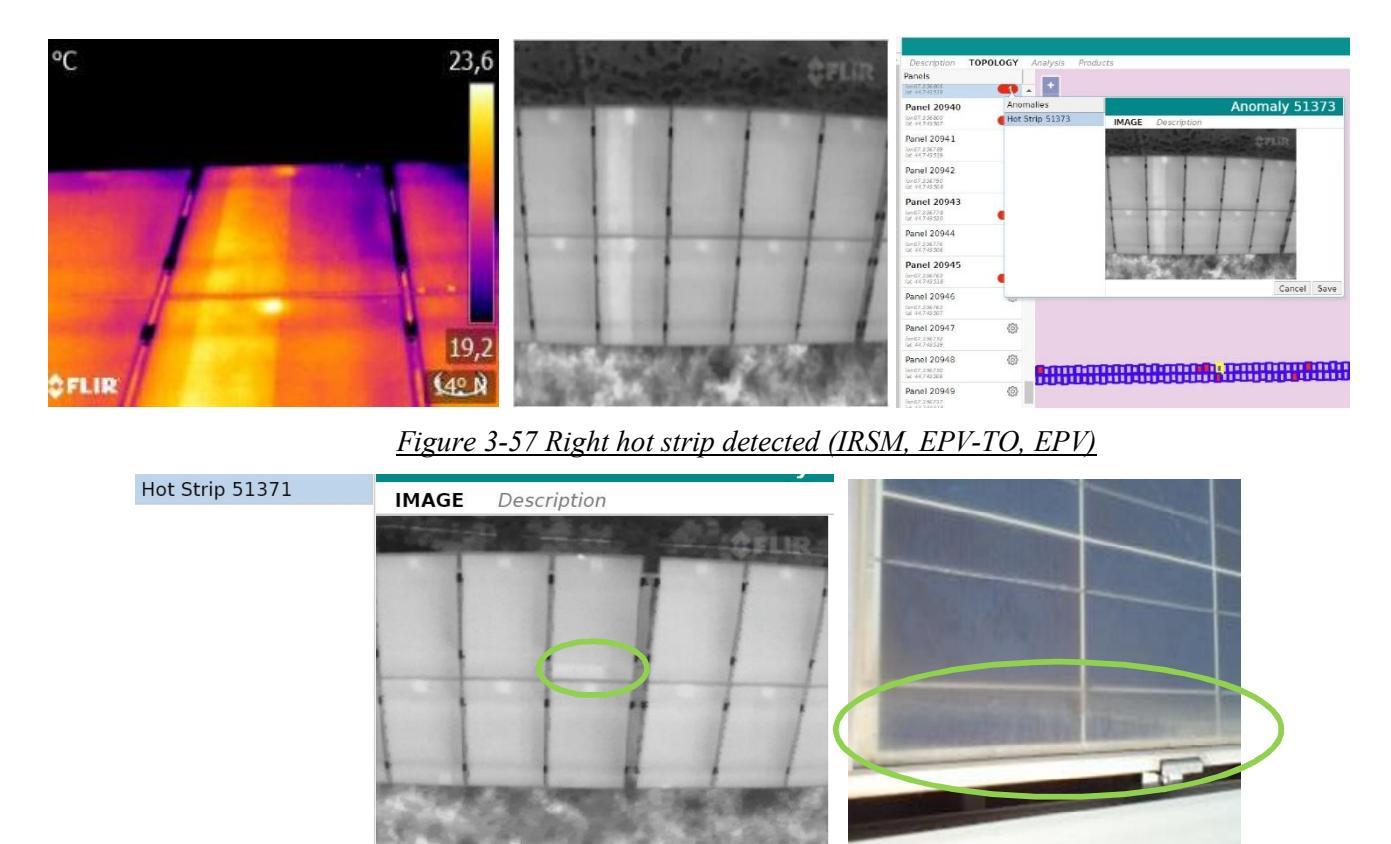
Figure 3-58 Wrong hot strip detected by EPV. Visual image shows soiling anomaly

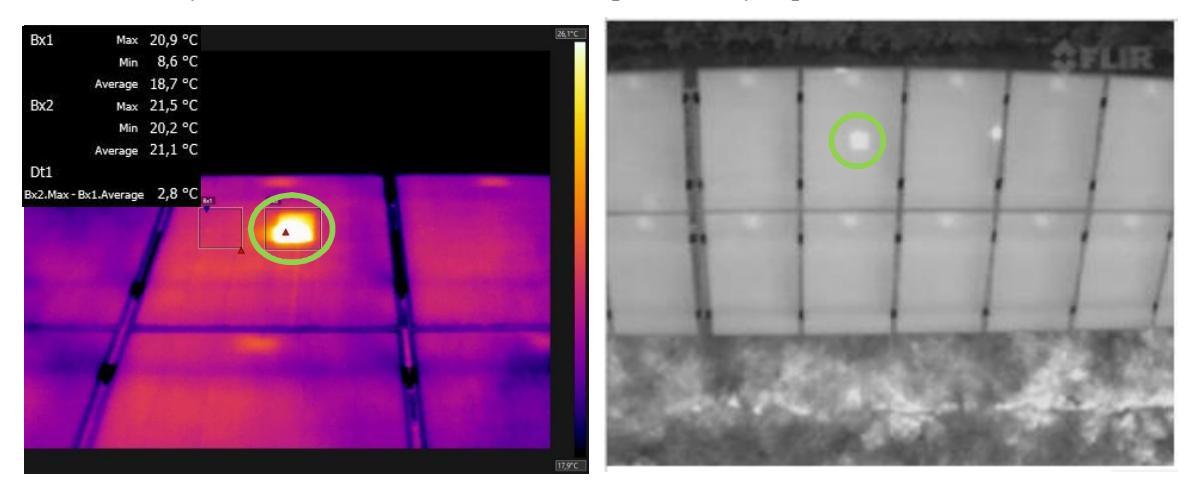
Hot spots are automatically detected by EPV with high performance: all the defects automatically located by the algorithm (6) are correctly linked to the PV module panels. Otherwise, the number of hot spots identified by EPV is greater than the hot spots computed in IRSM-EPV survey. This difference is due to the classification, computed manually by the thermal operator, of the hot spot in relation to the profile temperature on the cells (see 3.3). This function is not implemented in the EPV platform; therefore all hot spot anomalies are automatically stored in the SC platform. In this way, a conservative estimation of hot spot anomaly is performed.

Figure 3-59 Minor hot spot detected with IRSM and EPV

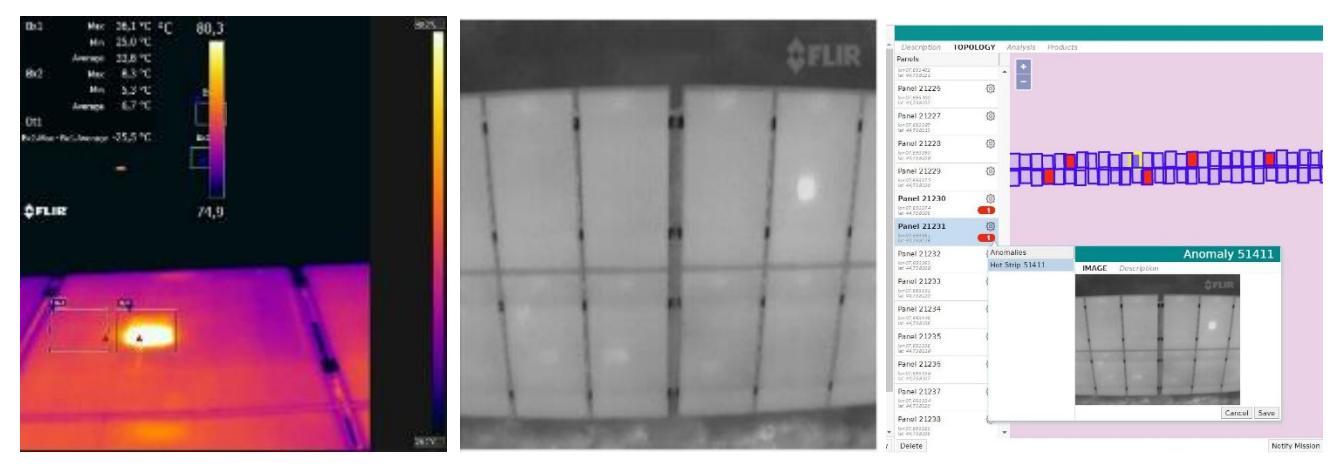
Figure 3-60 Right hot spot detection (IRSM, EPV-TO, EPV)

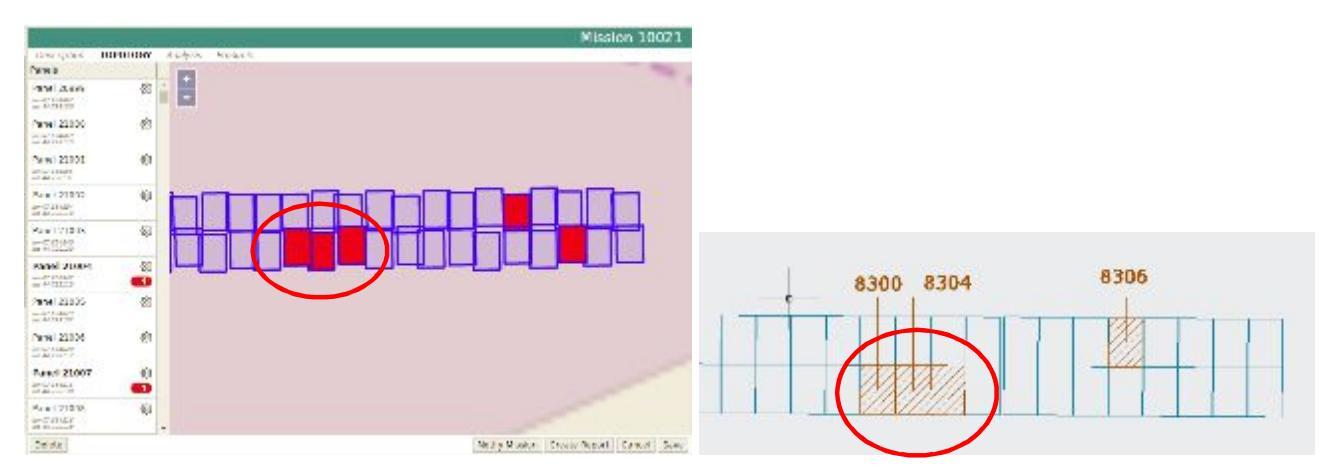
Hot spots are automatically located with a performance indicator of 82%. 6 anomalies are wrongly detected in the geometric entities. As showed in Figure 3-61 some defected modules are translated of one panel position in direction east compared to the right position. Furthermore, the number of anomalies automatically extracted is greater than the number located with IRSM-EPV. The cause of his problem is the same already found in the previous tests.

Figure 3-61 Wrong detection of hot spot. (East translation). Geometric layout extracted by EPV (left image). Geometric layout with the indication of modules affected by hot spot (IRSM – EPV, right

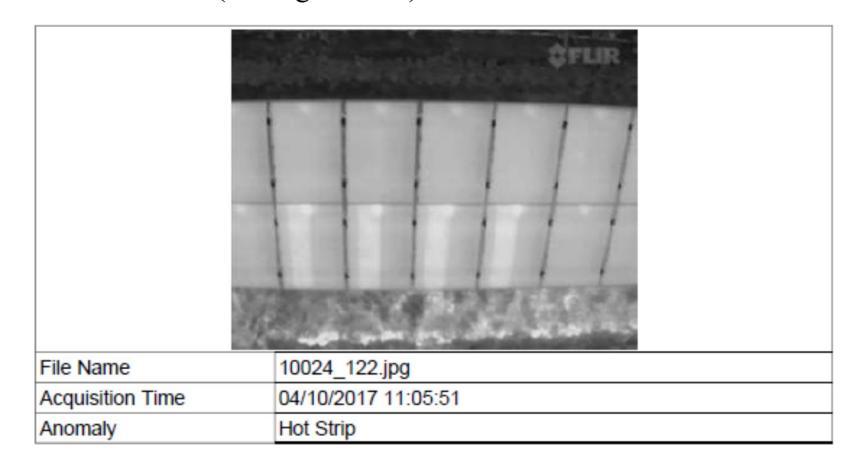
Figure 3-63 IR image associated to a hot strip fault. In the image there are 4 hot strips. Without a graphical indication, it is not possible to locate the damaged module
