Doc. No:	EASY-ENTEC-D10.1
ISSUE:	1.1
<b>D</b> ATE:	
<b>Sheet:</b>	1 of 95
CLASSIFICATION:	Unclassified

Prepared by			
	Mattia Alladio,		
	Mattia Bussi,		
	Davide Marenchino,		
	Paolo Oberto,		
	Claudio Rinaudo		
	Verified by		
	Davide Marenchino,		
	Paolo Oberto		
	Approved by		
Marco Nisi			
Company			
ENTEC S.p.A.	recnologie per l'energia

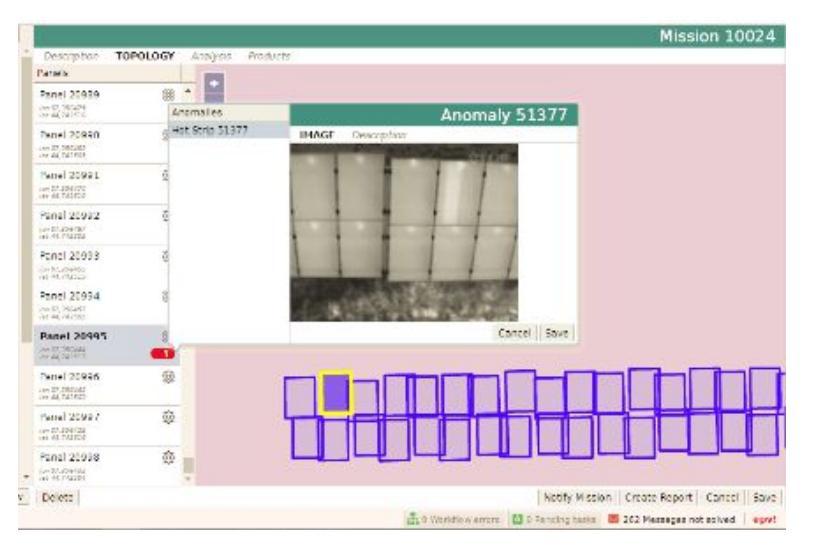
Figure 3-50 PVT3. Graphical layout and metadata associate

- Identification of anomaly on the IR image. On the image associated to each ID module is not signalized the position of anomaly (see <u>Figure 3-50</u>). Consequently, in case of defects located on neighbouring modules, it is not possible to link PV module and anomaly.

- Position of PV module. The position of a PV module is referred to geographic coordinates assessed by the EPV algorithms. In some cases, it is useful to have a "relative position" of each PV module in terms of row and column. Therefore, it is recommended to add this metadata on the SC platform.

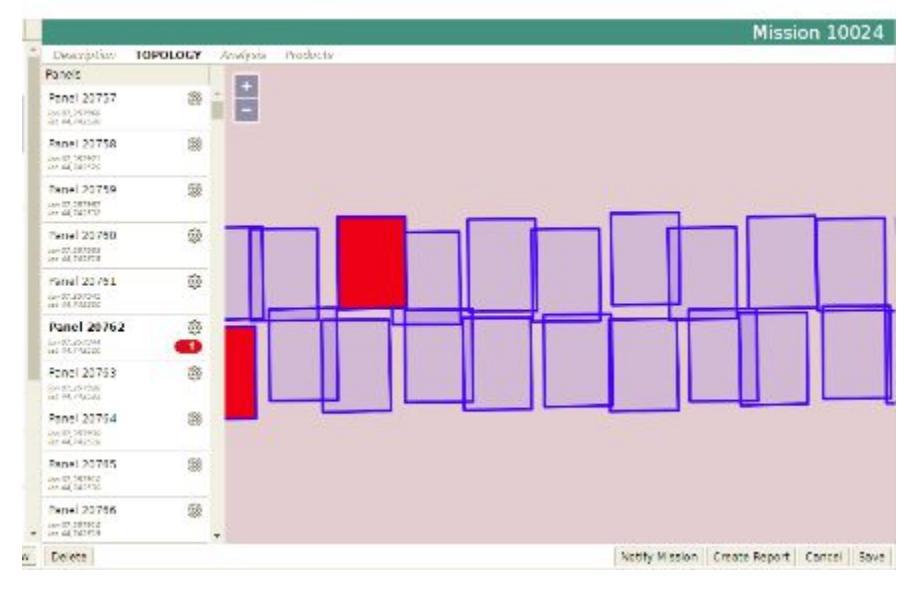
Figure 3-52 Particular of geometric output data

- Graphical output data provides row geometric entities estimated by EPV algorithms. It is recommended to perform a post processing geometric process of the geometric entities, in order to supply a graphical output composed by regular shapes of PV module.

- It is recommended to perform other tests with the last GNSS receiver configuration (RTK double frequency RTKITE receiver) in order to confirm the performance level just provided.

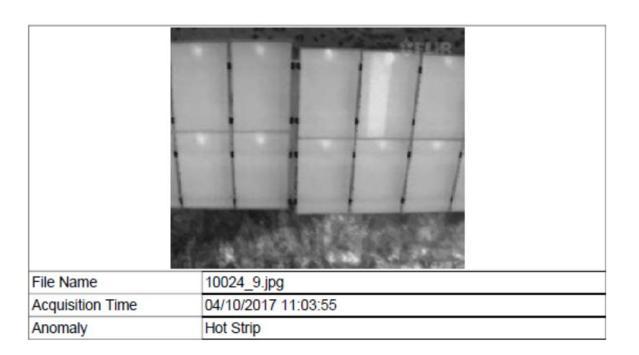
Figure 3-62 Report example

L'analisi effettuata su 242 pannelli ha permesso di riscontrare la presenza di 27 pannelli affetti da anomalia, con una difettosità pari al 11.16%.
